FULL RESERVE STUDY

Waterview Estates Owners Association, Inc.

Richmond, Texas

April 20, 2016

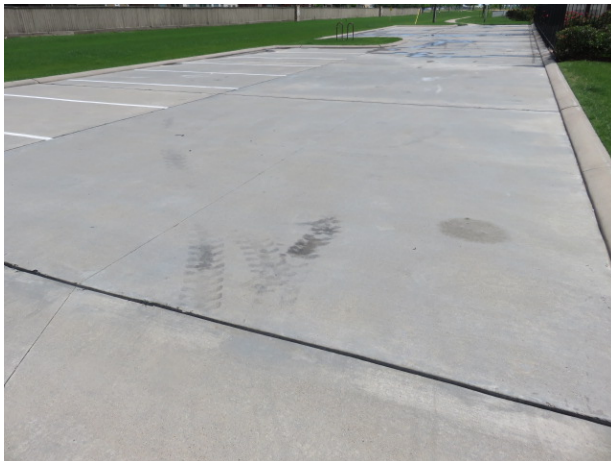
Concrete parking area in good condition

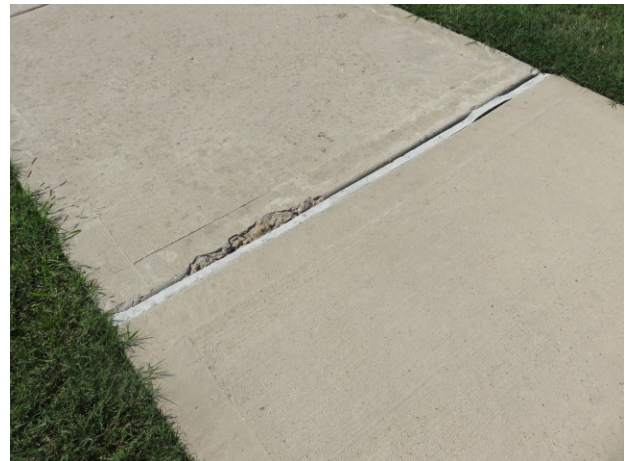
Isolated concrete sidewalk deterioration along joint

These applications of concrete have useful lives of up to 65 years although isolated deterioration of limited areas of concrete is common. Inclement weather, inadequate subsurface preparation and improper concrete mixtures or finishing techniques can result in premature deterioration such as settlement, chips, cracks and spalls. Variable conditions like these result in

The Association should coordinate the concrete flatwork partial replacements on Line Items 4.120 and 4.140 of *Reserve Expenditures* to maximize the given amount of concrete in a single event. This will permit the use of a single contractor and likely achieve the most economical unit price for the work. The times and costs of these replacements may vary. However, the estimated expenditures detailed in *Reserve Expenditures* are sufficient to budget appropriate reserves.

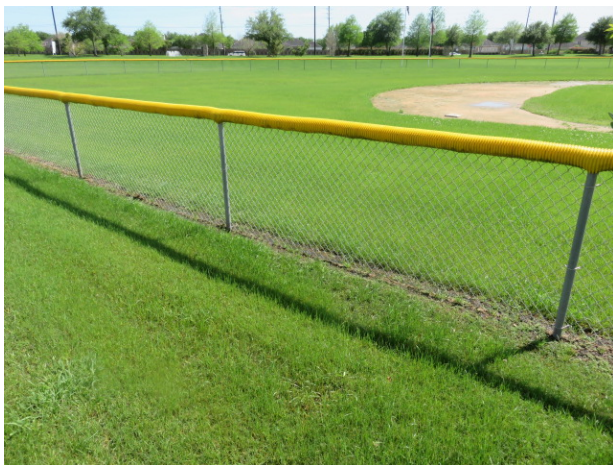
Fences, Chain Link – The Association maintains approximately 700 linear feet of chain link fences surrounding the baseball diamond including the backstop. The fences and backstop are original and in good condition.

Chain link fence surrounding baseball diamond

Chain link fences have useful lives of up to 25 years. We recommend the Association anticipate replacement by 2028. We suggest the Association consider the use of vinyl coated fences at the time of replacement to increase longevity for subsequent replacements. We depict this information on Line Item 4.220 of *Reserve Expenditures*.

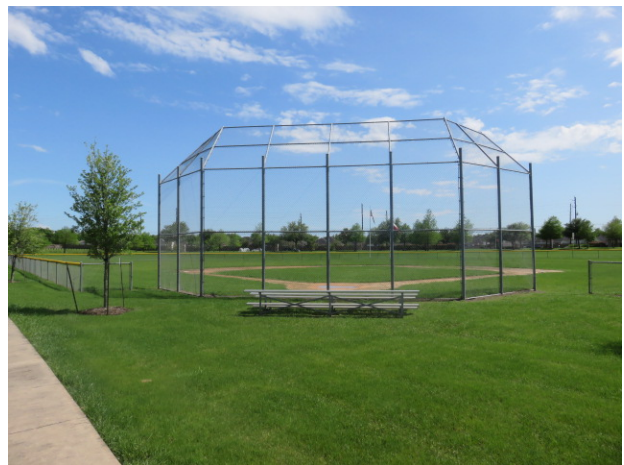
Baseball diamond backstop

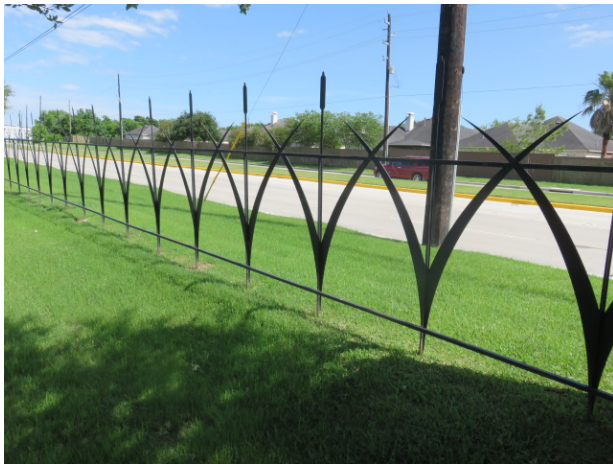
Metal fence at West Belfort Street

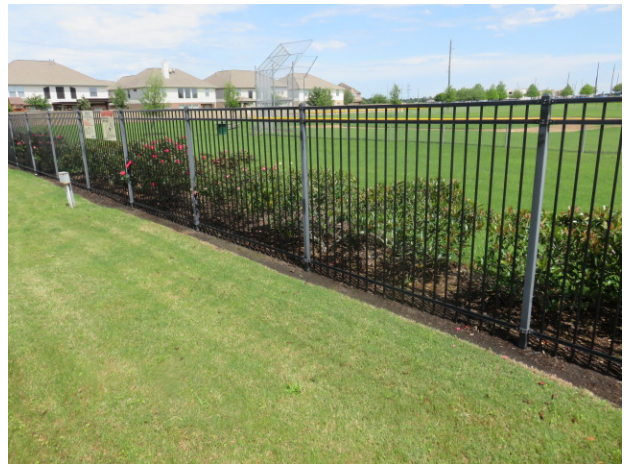
The fences are original to the construction of the respective locations and are in good condition. The protective finishes are likely original and are in fair overall condition. Our inspection notes finish deterioration and isolated rust throughout the community.

Pool fence, note finish deterioration

Fences of this type have long useful lives of 25- to 35-years but are not maintenance free. Periodic maintenance should include applications of protective paint finish to the metal surfaces and partial replacement of deteriorated sections every six- to eight-years. Metal components at

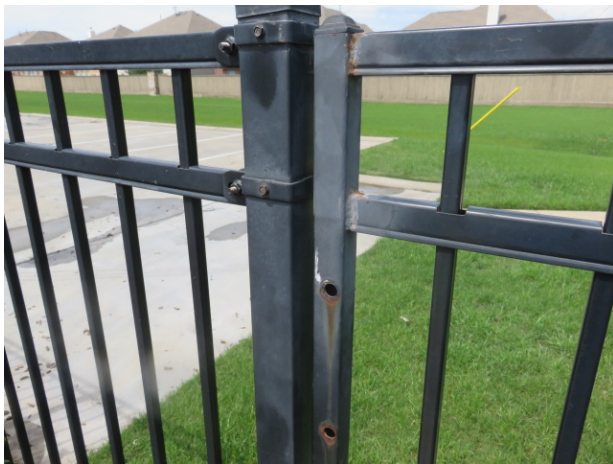
Rust and finish deterioration at pool fence

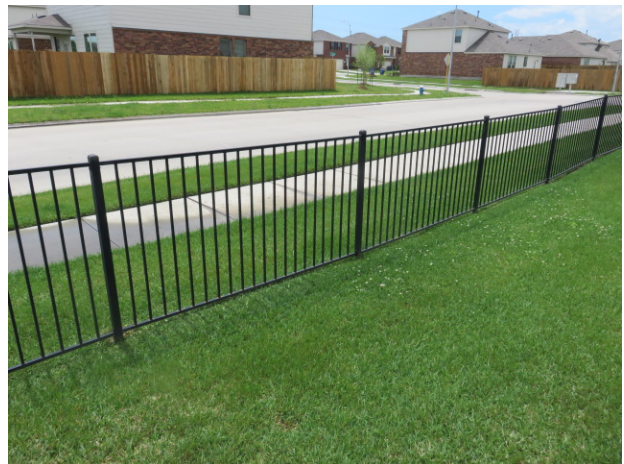
Metal fence surrounding splash pad

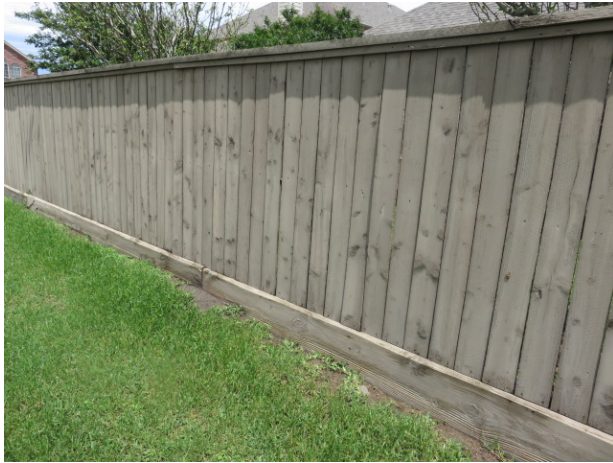
Solid board wood fencing at Waterview Estates Trail

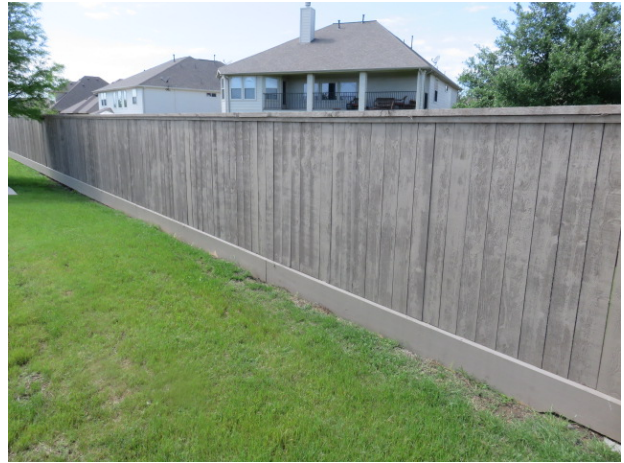
Recently replaced solid board wood fencing at West Belfort Street

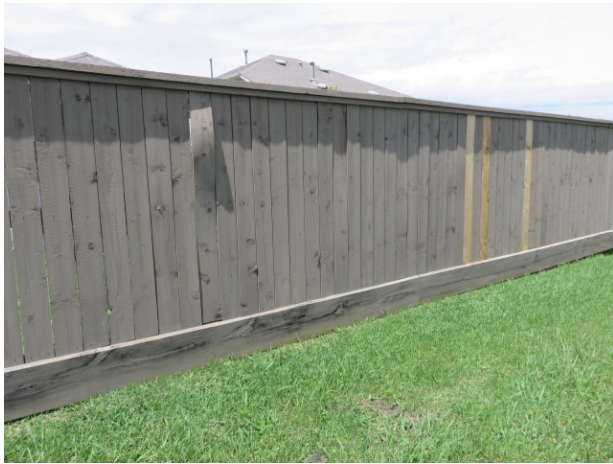
The fences at Belfort Street are in good condition at an age of less than one year. The fences at the perimeters of the north pocket parks are likely original and are in fair to poor condition. The fences at Waterview Estates Trail are original and in fair condition. These fences exhibit wood rot, particularly at the baseboards. Our inspection also notes fence lean, displacement and wood warp at the vertical boards.

Fence board warp and partial replacements

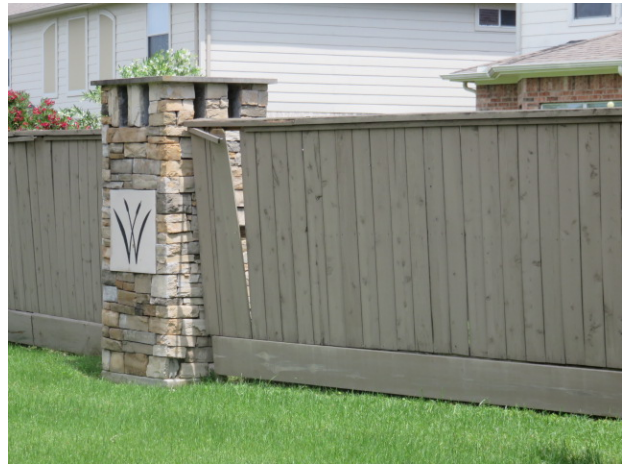
Fence lean

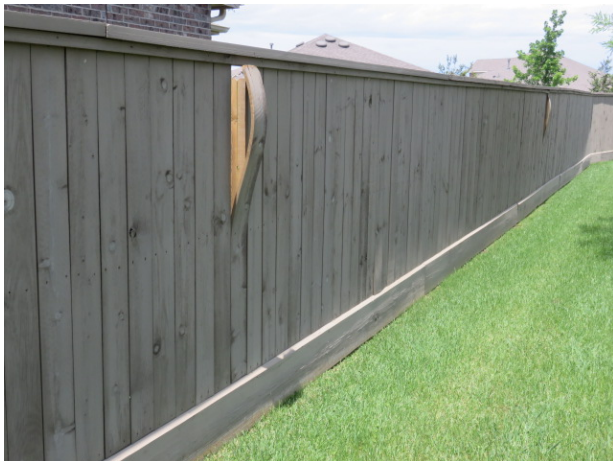
Fence board warp

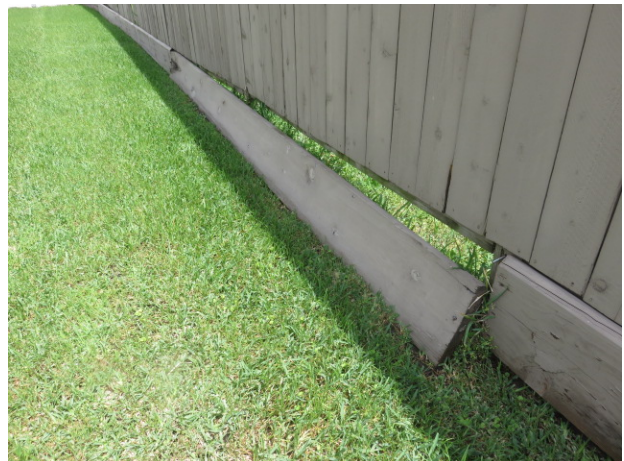
Base board deterioration and displacement

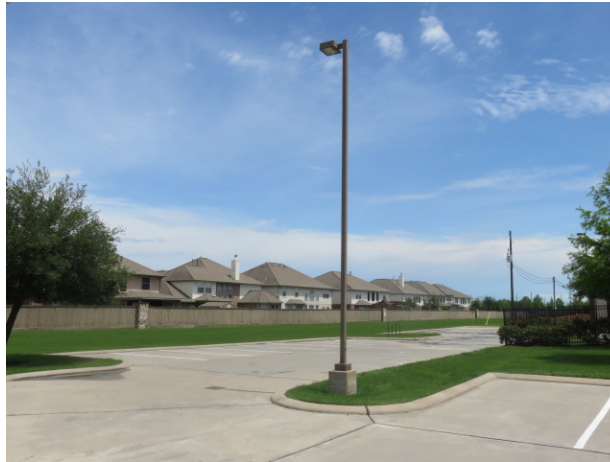
Light Poles and Fixtures - The Association uses four metal light fixtures atop steel poles to illuminate the parking area near the amenities. These elements are original, in good condition and have useful lives of up to 30 years.

Metal light pole and fixture at amenity center

The Association should anticipate the need for replacement by 2033. We note this information on Line Item 4.560 of *Reserve Expenditures*.

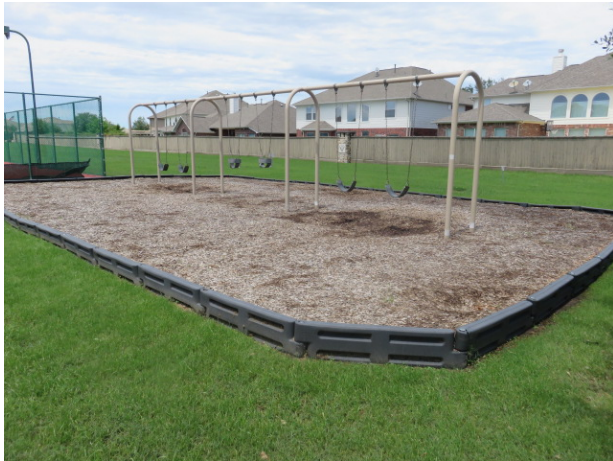
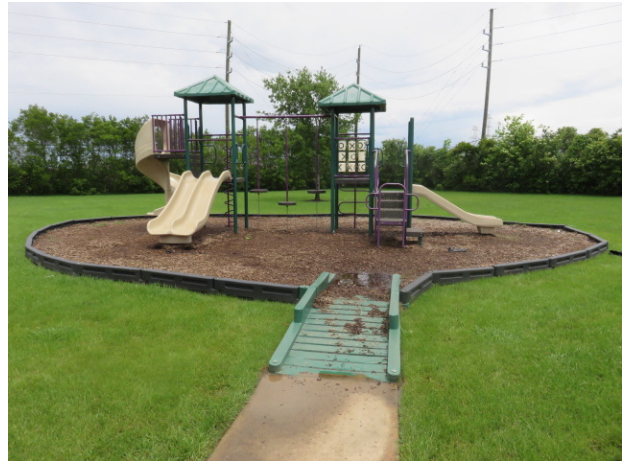
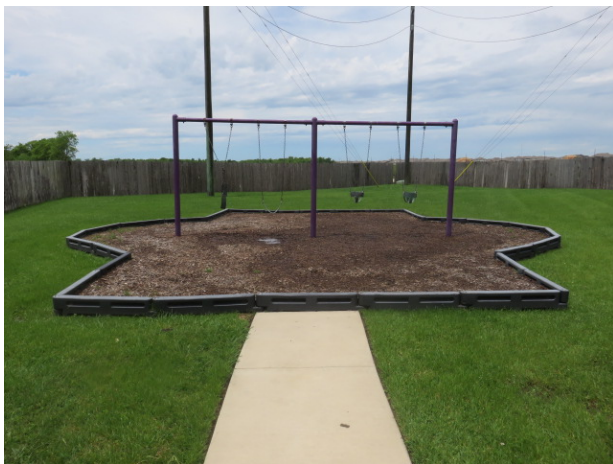
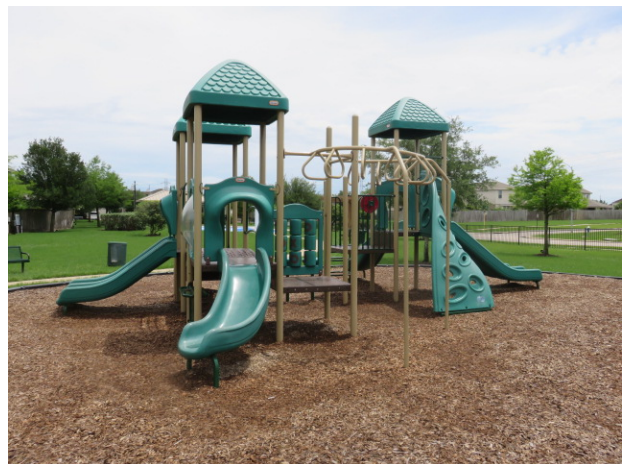
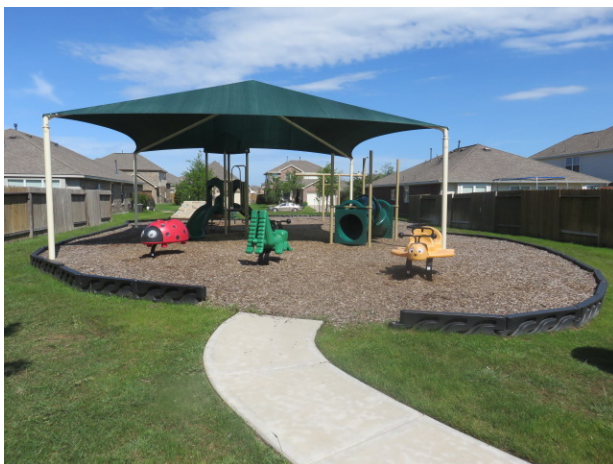
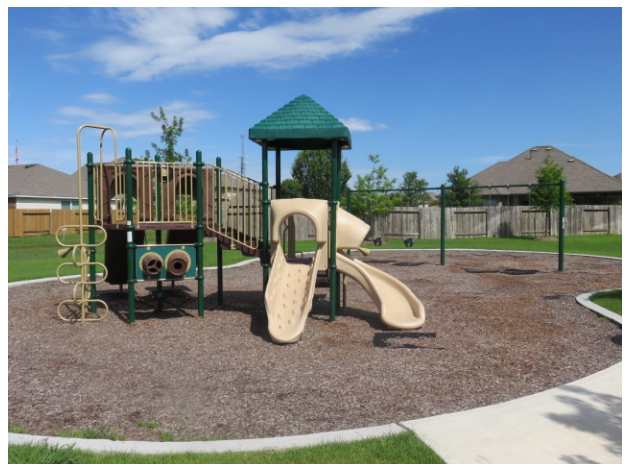
The playground equipment at the amenity center, north pocket parks and splash pad are in good condition at approximate ages of nine years. The playground equipment at Jay Thrush drive is in good condition at an age of five years. The playground equipment at Quill Rush Drive is in good condition at an age of one year.

Safety is the major purpose for maintaining playground equipment. We recommend an annual inspection of the playground equipment to identify and repair as normal maintenance loose connections and fasteners or damaged elements. We suggest the Association learn more about the specific requirements of playground equipment at PlaygroundSafety.org. We recommend the use of a specialist for the design or replacement of the playground equipment environment. Playground equipment of this type has a useful life of 15- to 20-years. We recommend replacement of the playground equipment at the amenity center, north pocket parks and splash pad by 2023 and again by 2039. We recommend replacement of the playground equipment at Jay Thrush Drive by 2027 and again by 2043. We recommend replacement of the playground equipment at Quill Rush Drive by 2031. We include this information on Line Items 4.660 through 4.662 of *Reserve Expenditures*.

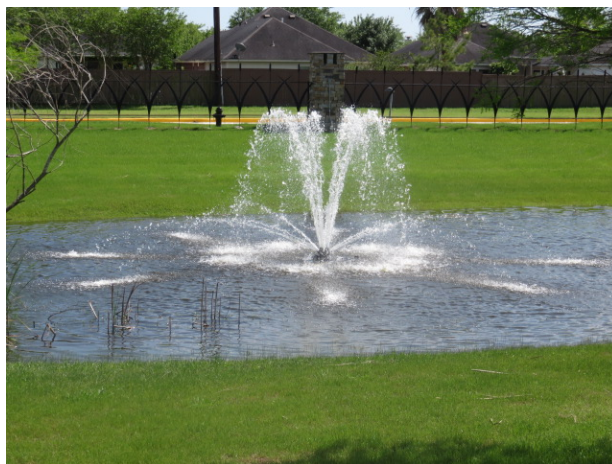
Ponds, Aerator – The Association maintains a pond near the main entrance to the community that utilizes a fountain style aerator. The use of small pumps, motors and aerators circulates pond water and increases the amount of entrained oxygen in the water, increasing water quality and reducing algae growths. The aerator is original and reported in good condition.

Fountain style pond aerator

Aerators have a useful life of 10- to 15-years. Based on age and condition, we recommend the Association anticipate replacement by 2020 and every 12 years thereafter. Line Item 4.700 of *Reserve Expenditures* notes our estimate of future costs and anticipated times of replacements.

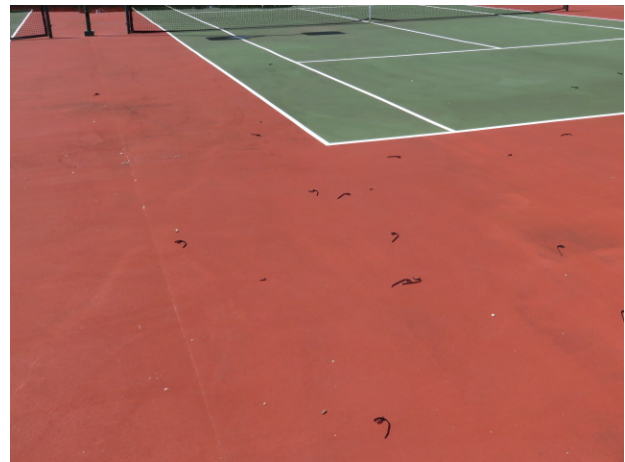
Color coat surface in fair condition

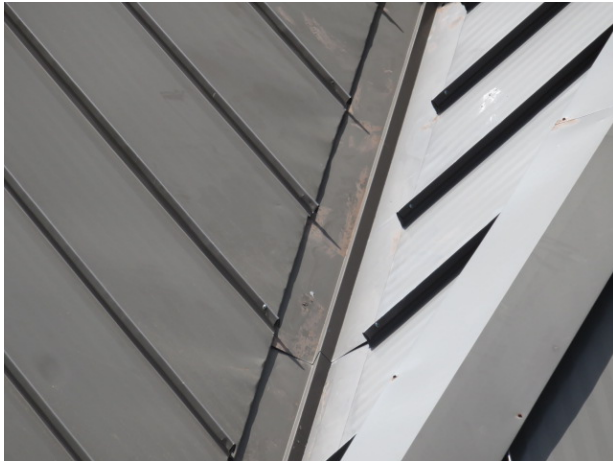
Roof rust at valley

These types of roofs have a useful life of up to 30 years. Based on the age and condition of the roof assemblies, we recommend Waterview Estates fund for replacement by 2033. We note this information on Line Item 5.600 of *Reserve Expenditures*. We recommend replacement with prefinished baked enamel sheet metal. Our cost includes replacement of aluminum gutters and downspouts in conjunction with roof replacements.

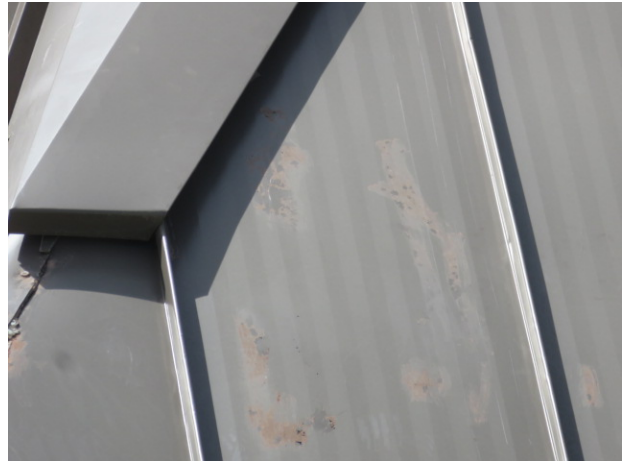
Roof rust at standing seam panel

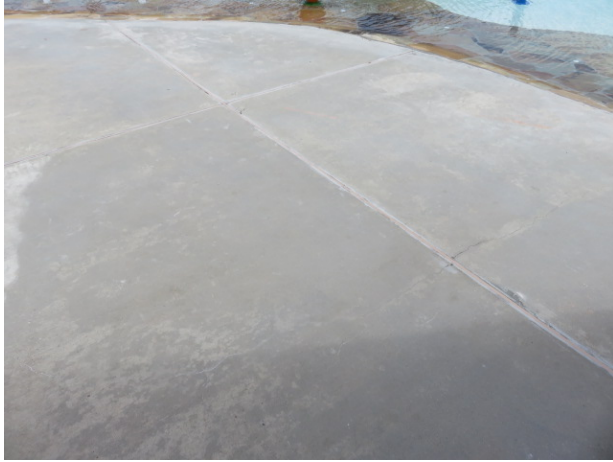
Concrete Deck - A concrete deck surrounds the pool and comprises approximately 7,750 square feet. The deck is original in good condition. Management and the Board inform us the deck was expanded and repaired in 2015. Our inspection notes isolated and minor deterioration.

Pool deck in good condition with isolated and minor deterioration

The useful life of a concrete pool deck is up to 60 years. However, we recommend the Association conduct inspections, partial replacements and repairs to the deck every 8- to 12-years. Inadequate subsurface preparation, improper concrete mixtures, poor finishing techniques, soil movement and water infiltration underneath the concrete deck can cause significant settlement and cracks in the concrete. The pool deck should also be free of trip

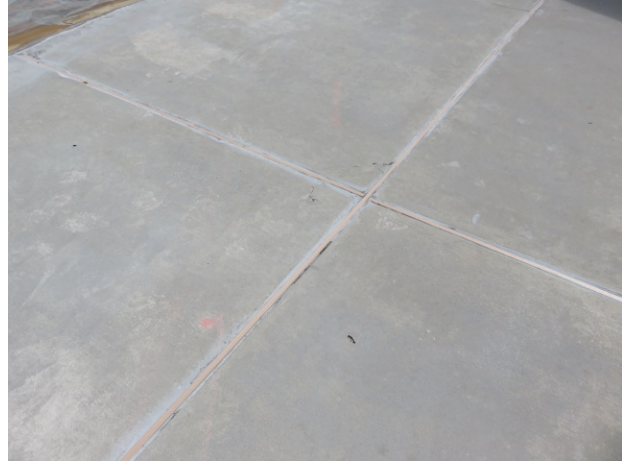
Control joints in good condition

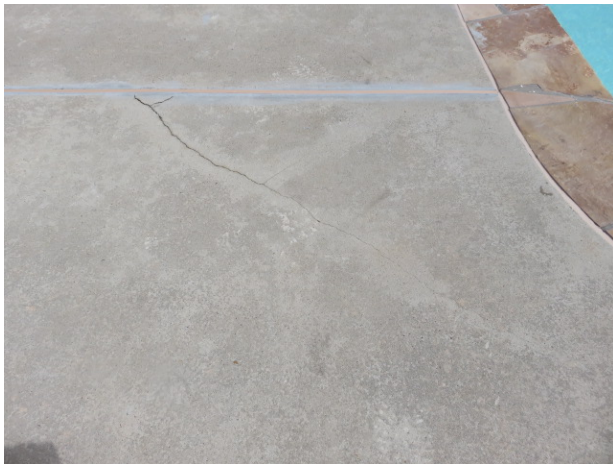
Isolated pool deck crack

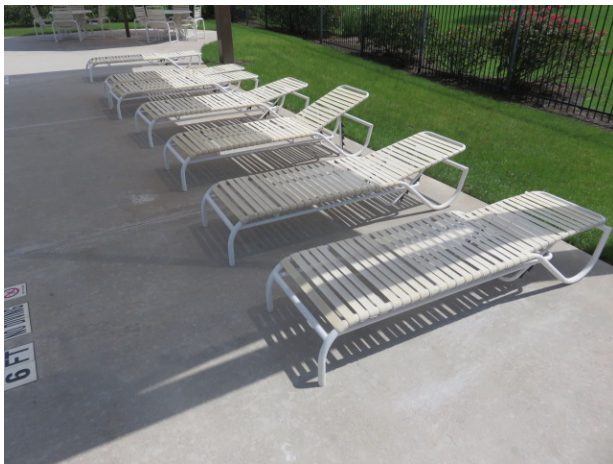
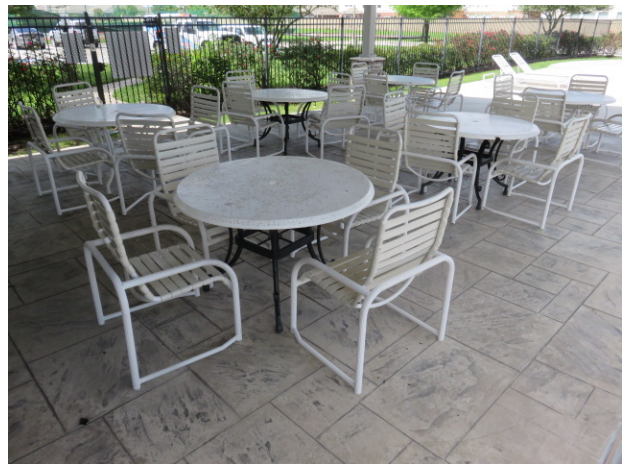
These items are original and are in fair condition.

Pool furniture has a useful life of up to 12 years. We recommend the Association budget an allowance for replacement of the pool furniture and fixtures by 2018 and every 12 years thereafter. The times and costs of these replacements may vary. However, we judge the amounts shown on Line Item 6.500 of *Reserve Expenditures* sufficient to budget appropriate

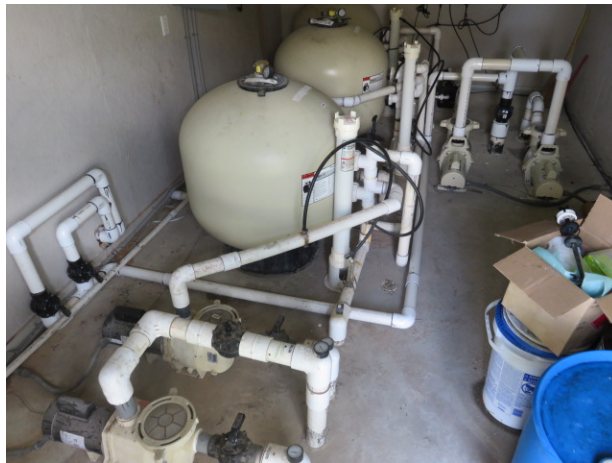
Management and the Board inform us a significant portion of the pool mechanical equipment was replaced in 2015 and all items are in good operational condition. Management and the Board also inform us the chlorination system is leased.

Pool mechanical equipment

Pool mechanical equipment has a useful life of up to 15 years. Failure of the pool mechanical equipment as a single event is unlikely. We recommend the Association anticipate replacement of up to fifty percent (50%) of the pool mechanical equipment by 2021 and every six years thereafter. We consider interim replacement of motors and minor repairs as normal maintenance. We note this information on Line Item 6.600 of *Reserve Expenditures*.

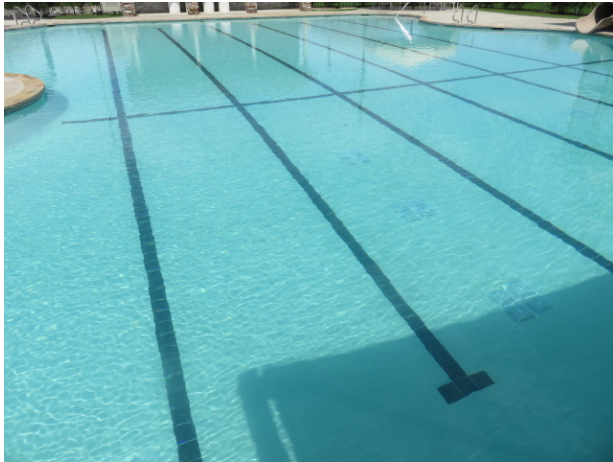
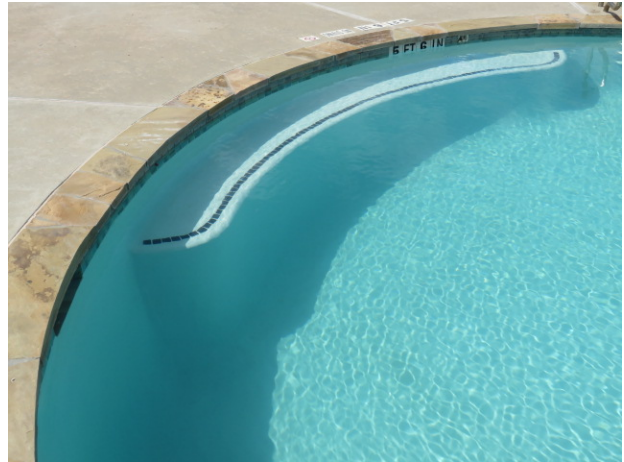
Pool Finish, Plaster - The pool wall and floor surfaces have a plaster finish of 5,690 square feet based on the horizontal surface area. The finish is in good condition at an age of one year. We note no visible deterioration of the finish.

This type of pool finish deteriorates with time and requires periodic maintenance and replacement. We recommend the Association anticipate the need to replace the finish and conduct related repairs every 8- to 12-years to maintain the integrity of the pool structure. Removal and replacement provides the opportunity to inspect the pool structure and to allow for partial repairs of the underlying concrete surfaces as needed. We recommend the Association budget for the following by 2025 and every 10 years thereafter:

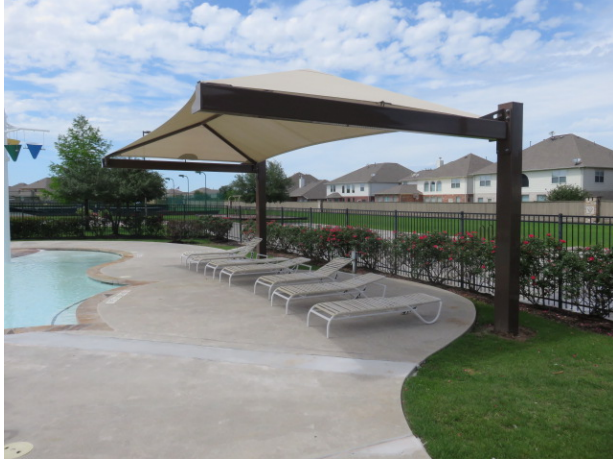
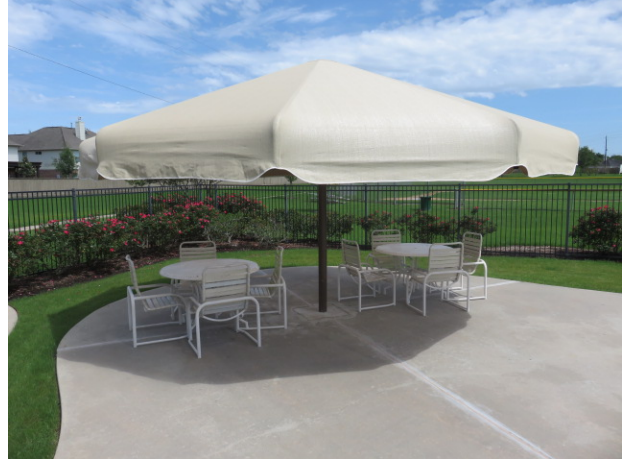
canopies and umbrellas with metal support frames. The shade structures are in good condition at an age of one year.

Shade structures of this type have useful lives of 15- to 20-years with the benefit of interim canvas replacements every six- to eight-years. Based on age and condition, we recommend replacement of the canvas canopies by 2021 and every six years thereafter, except when total replacement occurs by 2033. We depict this information on Line Items 6.880 and 6.890 of *Reserve Expenditures*.

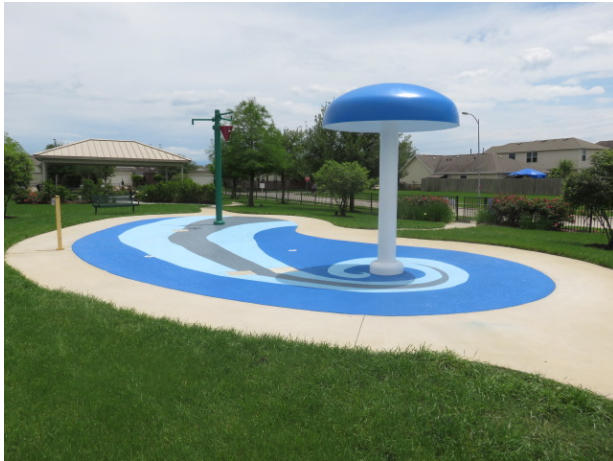
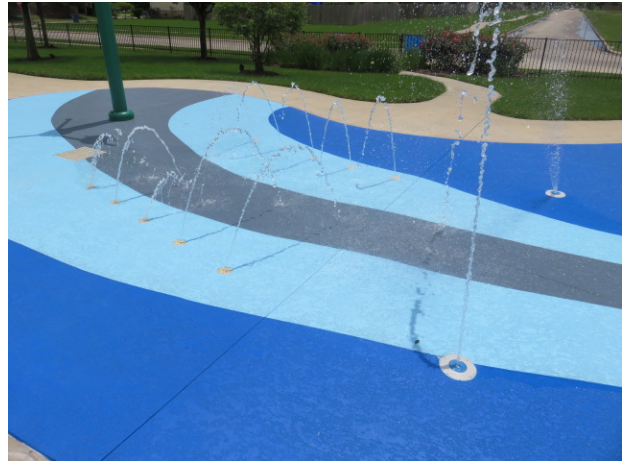
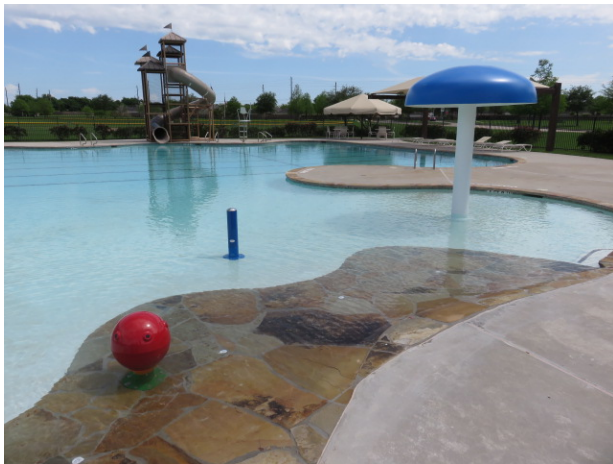
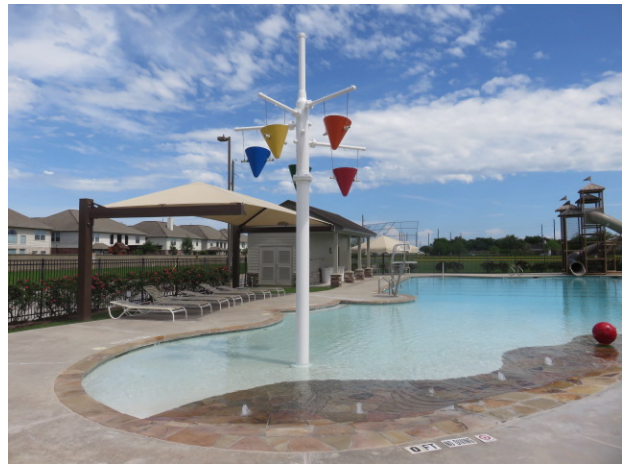
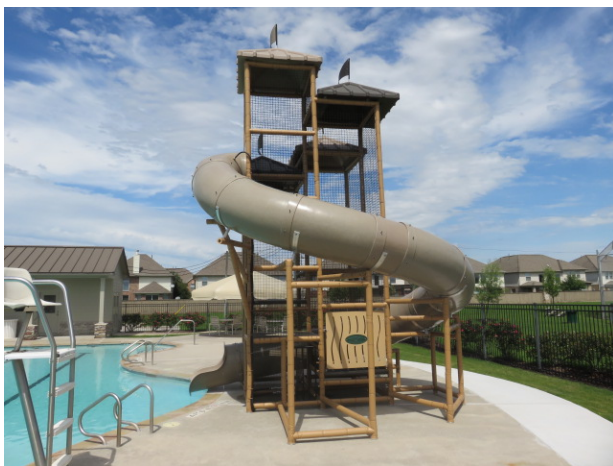
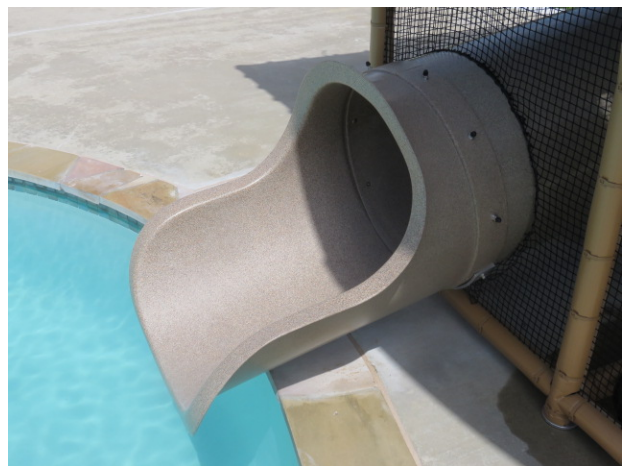
Water Features and Slide - Waterview Estates maintains the metal water features and spray nozzles at the splash pad and pool in addition to maintaining a composite water slide and platform at the pool. The water features and spray nozzles at the splash pad and pool are original and in good condition. Management and the Board inform us the Association refinished these components including a color coat application to the splash pad concrete surface in 2015. The water slide and platform is in good condition at an age of one year.
